# Distressed Water Pump Rebuilt and Coated with Belzona 1341N Hydrophobic Coating

ID: 9731

Industry: Power  
Application: CEP-Centrifugal Pumps  
Substrate: Cast Iron  
Products: Belzona 1311 (Ceramic R-Metal), Belzona 1321 (Ceramic S-Metal), Belzona 1341N (Supermetalgilde)

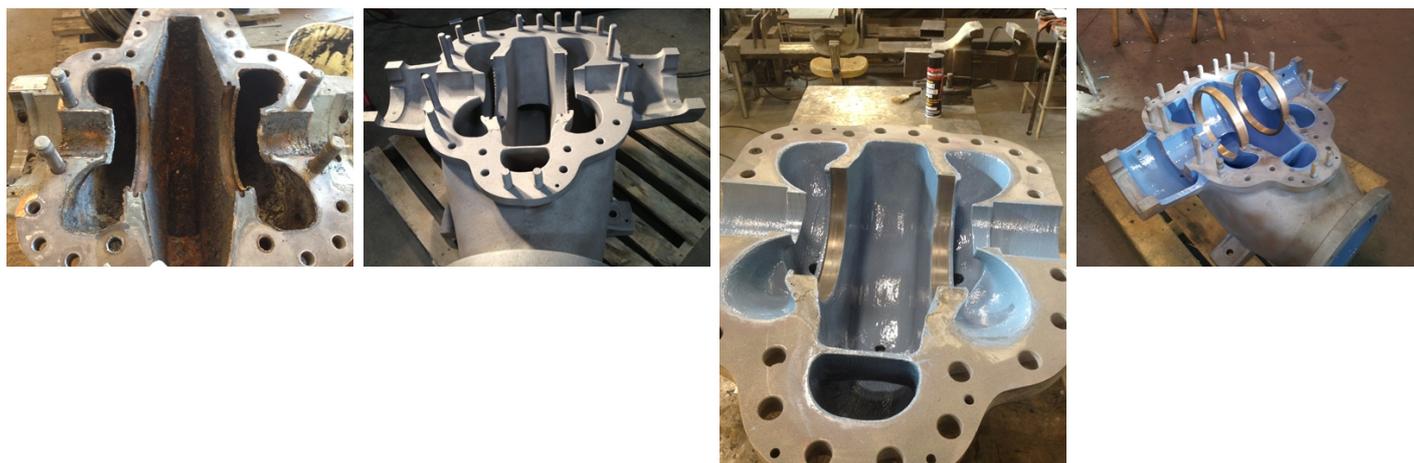
General damage to the pump casing, wear ring areas, and packing areas.

Grit blasted completed and ready for Belzona application.

After the wear rings and packing areas were rebuilt with Belzona 1311 (Ceramic R-Metal) the first coat of Belzona 1321 (Ceramic S-Metal) was applied.

Two coats of Belzona 1341N (Supermetalgilde) were applied. Pump is ready to be reassembled.

After a grit blast Belzona 1311 was used to rebuild the wear rings and packing areas. Then one coat of Belzona 1321 (Ceramic S-Metal) was applied by brush. This was followed by two coats of Belzona 1341N (Supermetalgilde), a hydrophobic coating for energy efficiency.
