# Belzona repairs scored shaft on a valve

ID: 9735

Industry: *Power*  
Application: *MPT-Mechanical Power Transmission*

Substrate: *Carbon steel*  
Products: *Belzona 1212*

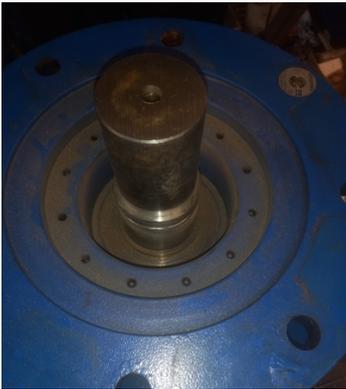
Surface preparation

The score was first ground out using a pencil grinder. It was also heated to remove any oil within the substrate. Belzona 1212 was then applied & overbuilt by ~2mm. The product was then dressed down smooth with the shaft surface.

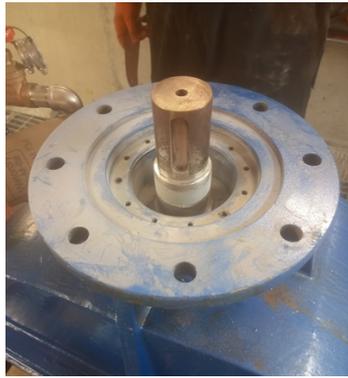
Belzona 1212 application

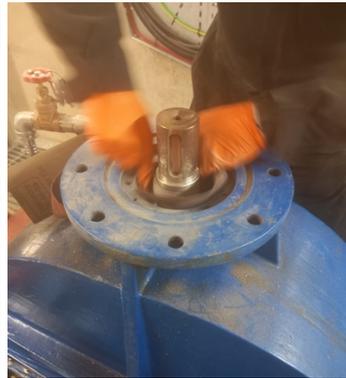
Dressing down repair
