Belzona SuperWrap II ABS approved system Repairs Leaks USNS PFC Dewayne T. Williams Vessel

ID: 9737

Industry:	Marine	Customer Location:	Guam
Application:	VPF-Valves, Pipes and Fittings	Application Date:	September 2024
Substrate:	Carbon steel		
Products:	Belzona 1161 (Super UW-Metal),Belzona 1982 (SuperWrap II)

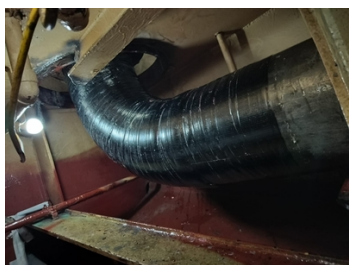
Pipe Section One - SuperWrap
II Completed

The application method was in accordance with SuperWrap II best practices in application of the system. The surface was prepped with an MBX to and SSPC SP-11 Bare Metal Machine finish. Belzona 1161 was used in the welds and joint areas to smooth and even the surface for wrapping. Two wraps were done as per the specification.

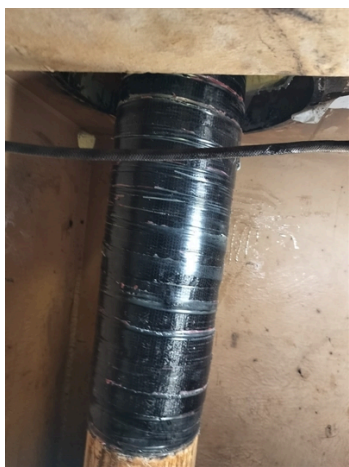
Pipe Section Two SuperWrap II
Completed

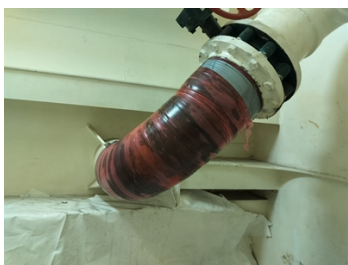
Pipe Section Three SuperWrap
II Completed
