Belzona SuperWrap II ABS approved system Repairs Leak USNS Tippecanoe

ID: 9738

Industry: Marine
Application: VPF-Valves, Pipes and Fittings
Substrate: Other
Products: Belzona 1161 (Super UW-Metal), Belzona 1982 (SuperWrap II)

Customer Location: Guam
Application Date: September 2024

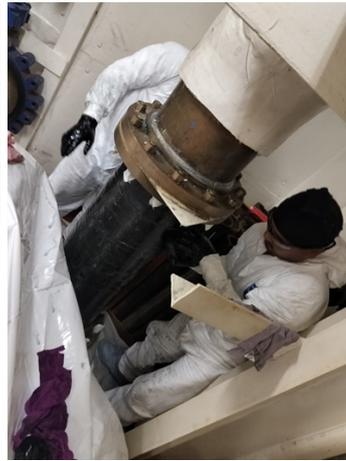
SuperWrap II being applied on the pipe section

The application method was in accordance with SuperWrap II best practices in application of the system. The surface was prepped with an MBX to and SSPC SP-11 Bare Metal Machine finish. Belzona 1161 was used in the leak area to do a small plate bond. Two wraps were done as per the specification.

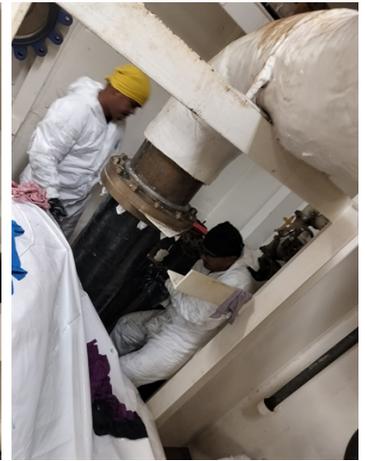
SuperWrap II pipe section being finished.
