# Belzona SuperWrap II ABS approved system Repairs Leak USNS Tippecanoe

Industry: Marine  
Application: VPF-Valves, Pipes and Fittings  
Substrate: Other  
Products: Belzona 1161 (Super UW-Metal), Belzona 1982 (SuperWrap II)

Customer Location: Guam  
Application Date: September 2024

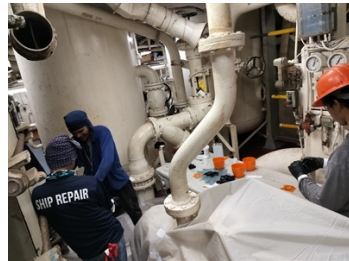
Work and access area for repair

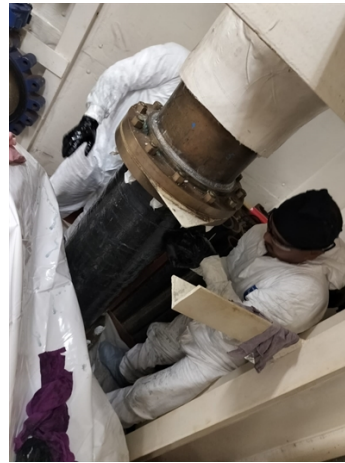
SuperWrap II being applied on the pipe section

The application method was in accordance with SuperWrap II best practices in application of the system. The surface was prepped with an MBX to and SSPC SP-11 Bare Metal Machine finish. Belzona 1161 was used in the leak area to do a small plate bond. Two wraps were done as per the specification.

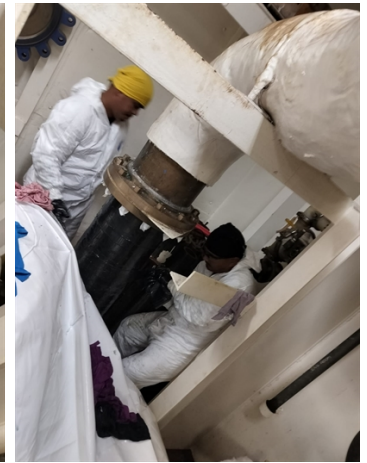
SuperWrap II pipe section being finished.
