# BELZONA SOLUTIONS FOR REBUILDING AND COATING OF CHILLERS

**Industry:** Heating, Ventilation & Air Conditioning  
**Application:** HEX-Heat Exchangers  
**Substrate:** Carbon steel  
**Products:** Belzona 1121 (Super XL-Metal), Belzona 5821

**Customer Location:** DUBAI, UNITED ARAB EMIRATES  
**Application Date:** January 2025

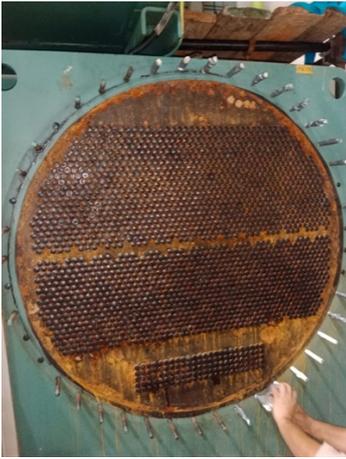
The tube sheet and end cover of the chiller units were severely corroded, causing a significant decline in efficiency. Furthermore, wear around the gasket seals prevented a proper seal, further affecting the chiller's performance.

Picture taken during site visit noticed heavy corroded and damaged and measurements taken.

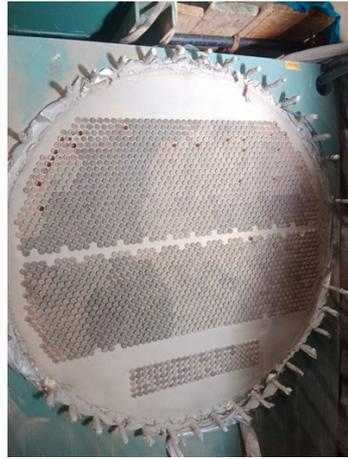
Work in progress, surface preparation with grit blast, rubber and plastic plug inserted.

The surface was grit blasted and thoroughly cleaned, with plastic/rubber plugs inserted to prevent media from entering the tubes during preparation. The plugs were then removed and reinserted before product application. Belzona 1121 was used to rebuild and resurface the damaged areas, while Belzona 5821 was applied in a two-coat system to protect the tube sheet and end cover from corrosion and erosion.

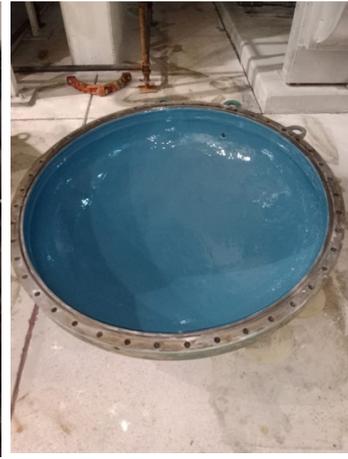
Rebuilding completed Belzona 1121.

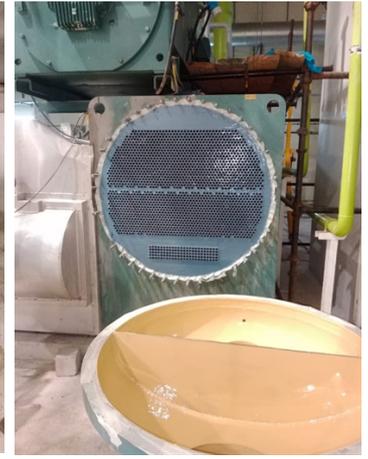
Belzona 5821 applied as 2 coat system to protect the tube and the end cover.
