BELZONA SOLUTIONS FOR REBUILDING AND COATING OF CHILLERS

ID: 9739

Industry: Heating, Ventilation & Air Conditioning
Application: HEX-Heat Exchangers
Substrate: Carbon steel
Products: Belzona 1121 (Super XL-Metal), Belzona 5821

Customer Location: DUBAI, UNITED ARAB EMIRATES
Application Date: January 2025

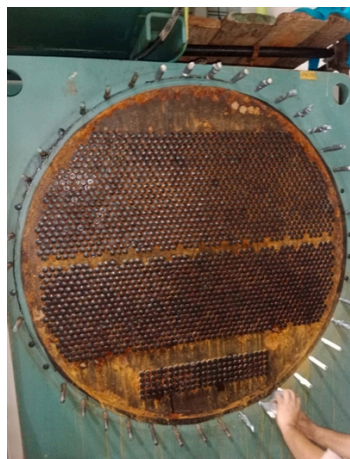
The tube sheet and end cover of the chiller units were severely corroded, causing a significant decline in efficiency. Furthermore, wear around the gasket seals prevented a proper seal, further affecting the chiller's performance.

Picture taken during site visit noticed heavy corroded and damaged and measurements taken.

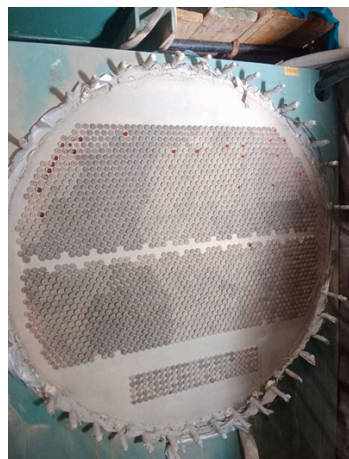
Work in progress, surface preparation with grit blast, rubber and plastic plug inserted.

The surface was grit blasted and thoroughly cleaned, with plastic/rubber plugs inserted to prevent media from entering the tubes during preparation. The plugs were then removed and reinserted before product application. Belzona 1121 was used to rebuild and resurface the damaged areas, while Belzona 5821 was applied in a two-coat system to protect the tube sheet and end cover from corrosion and erosion.

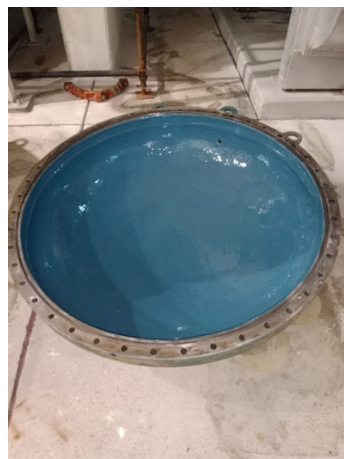
Rebuilding completed Belzona 1121.

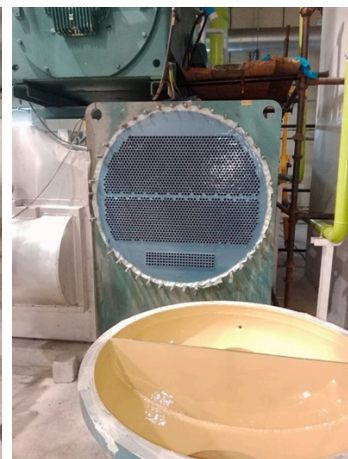
Belzona 5821 applied as 2 coat system to protect the tube and the end cover.
