BELZONA SOLUTION FOR REBUILDING AND COATING OF STUFFING BOX

ID: 9740

Industry: Fluid Flow
Application: CEP-Centrifugal Pumps
Substrate: Carbon steel
Products: Belzona 1121 (Super XL-Metal), Belzona 1321 (Ceramic S-Metal)

Customer Location: DUBAI, UNITED ARAB EMIRATES
Application Date: January 2025

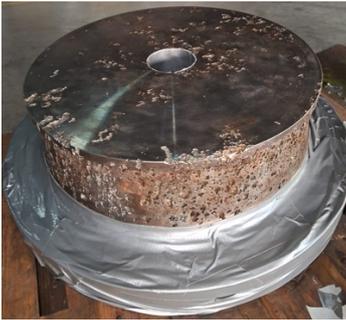
The stuffing box of the pump experienced erosion and corrosion, leading to pitting damage on the internal surfaces and impacting performance.

Severely corroded equipment.

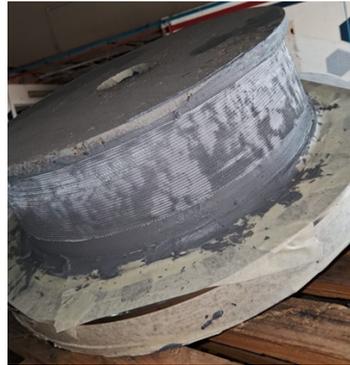
During the rebuilding works using Belzona 1121.

Belzona 1121 and Belzona 1321 were applied following the guidelines of Belzona System Leaflets CEP-01 and CEP-03. The corroded areas were rebuilt manually using a stiff bristle brush and the provided plastic applicator, in accordance with the approved IFU.

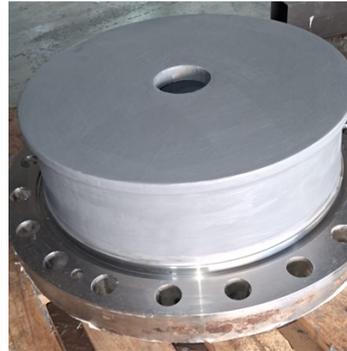
Re-built stuffing box after the application of Belzona 1121.

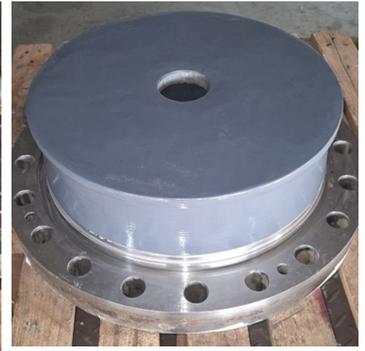
Final equipment after the Belzona 1321 application.
