# BELZONA SOLUTION FOR REBUILDING AND COATING OF STUFFING BOX

ID: 9740

Application: CEP-Centrifugal Pumps

Customer Location: DUBAI, UNITED ARAB EMIRATES

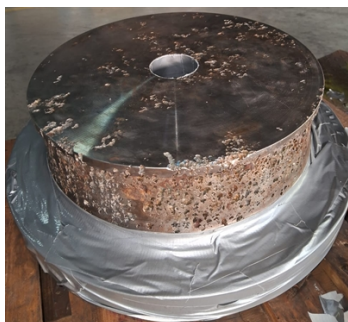
The stuffing box of the pump experienced erosion and corrosion, leading to pitting damage on the internal surfaces and impacting performance.

Severely corroded equipment.

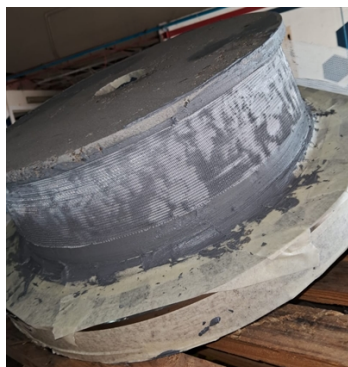
During the rebuilding works using Belzona 1121.

The corroded areas were rebuilt manually using a stiff bristle brush and the provided plastic applicator, in accordance with the approved IFU.
