Corrosion Prevention in Condenser Exchanger with Belzona 1321

ID: 9742

Industry: Power
Application: HEX-Heat Exchangers
Substrate: Carbon steel
Products: Belzona 1321 (Ceramic S-Metal), Belzona 9111 (Cleaner Degreaser)

Customer Location: Turkey
Application Date: January 2025

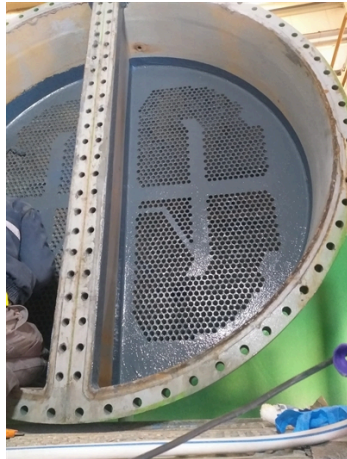
After application

The application was carried out in accordance with Belzona Know-How System Leaflet HEX-3. Belzona 1321 was applied after mechanical surface cleaning to prevent further corrosion between the surface and tubes .
