Corrosion Prevention in Condenser Exchanger with Belzona 1321

ID: 9742

Application: HEX-Heat Exchangers

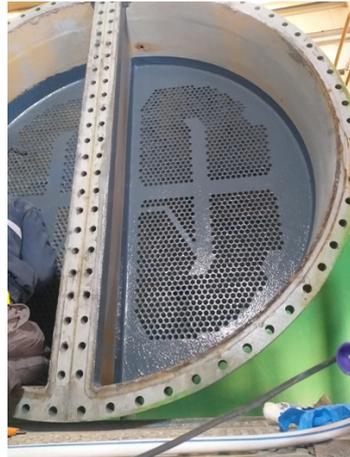
Corrosion between the surface and tubes due to water flow in the condenser exchanger

Before application

Due to the water passing through the condenser exchanger, corrosion was occurring between the surface and tubes

The application was carried out in accordance with Belzona Know-How System Leaflet HEX-3. Belzona 1321 was applied after mechanical surface cleaning to prevent further corrosion between the surface and tubes .

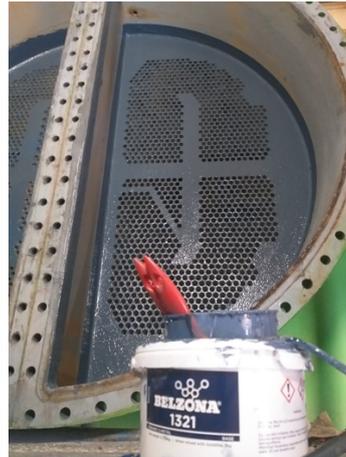
After application
