# Scrapped Pump Brought Back to Life with Belzona

ID: 9743

Industry:	Water / Wastewater	Customer Location:	TURKEY
Application:	CEP-Centrifugal Pumps	Application Date:	January 2025
Substrate:	Cast Iron		
Products:	Belzona 1311 (Ceramic R-Metal), Belzona 1321 (Ceramic S-Metal)

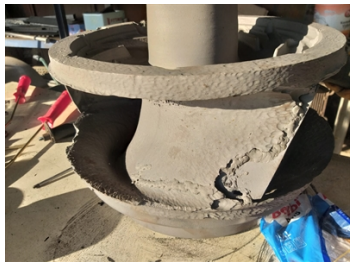
Before application

Surface losses resulting from erosion experienced in the impeller of the sludge pump used in the wastewater treatment plant.

In a wastewater treatment facility, a sludge pump suffered significant erosion on its impeller, leading to severe surface loss.
