Belzona Solutions for Gas Turbine Air Intake Roof Repair

ID: 9745

Application: RPA-Roof Problem Areas

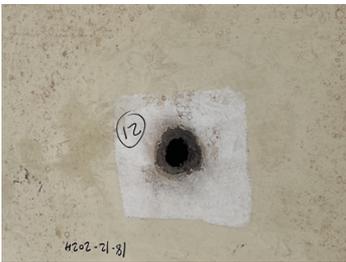
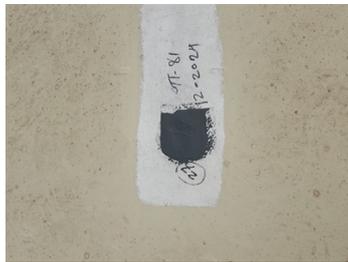
Gas Turbine (GT) air intake roof is experiencing severe corrosion due to prolonged exposure to atmospheric moisture, humidity, and environmental contaminants.

Surface preparation was performed using hand abrasion to ensure optimal adhesion.

Repair plates were then cold-bonded over the perforations using Belzona 1161.

Entire repaired area was coated with Belzona 5831 and Belzona 5811, ensuring long-term protection.
