# Belzona Salvages Hydrogen Cooler Heads

Industry: Power  
Application: HEX-Heat Exchangers  
Substrate: Cast Iron  
Products: Belzona 1311 (Ceramic R-Metal)

Customer Location: Dayton, OH  
Application Date: May 1987

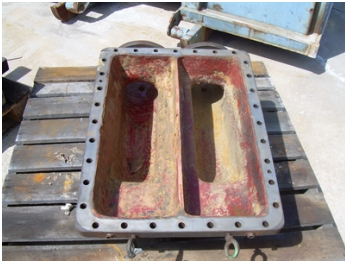
Severe pitting corrosion along with erosion of the division bars was affecting efficiency.

Overview of damaged hydrogen cooler head

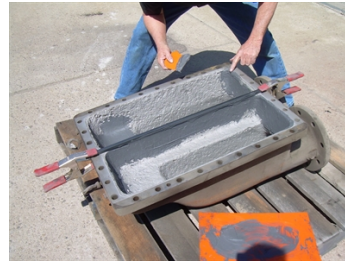
Division bar cast and cooler head being coated with Belzona 1311

This was grit blasted to SSPC SP10. Bar stock was clamped on to reform the division bar then the whole unit was coated with Belzona 1311 (Ceramic R-Metal).

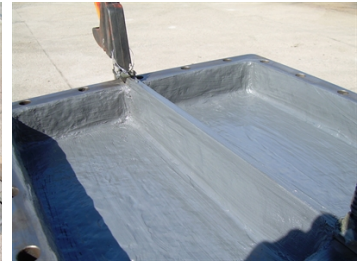
Finished application
