Belzona restores Waterslide Tower at local swimming pool

Application: FPA-Floor Problem Areas

Substrate: Concrete

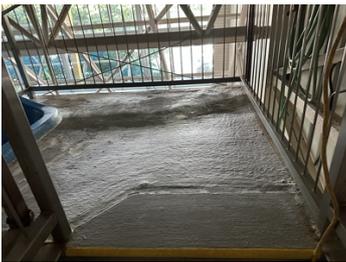
The connecting points between the concrete deck, fiberglass slide and aluminum stairs had all failed. Water was leaking between causing significant corrosion of the Waterslide tower structure

Current state of waterslide tower platform. The current coating systems had failed and water was passing through the concrete corroding the steel tower structure

All areas were prepared using diamond cup grinders. The area was masked and repairs / resurfacing was completed using Belzona 4111 Magma Quartz. The area was then coated with 2 coats of Belzona 5231 SG Laminate.

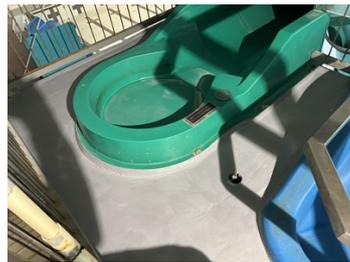
Sealing between the fiberglass slides and platform was needed

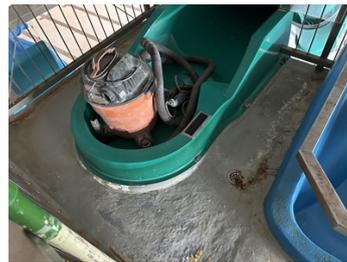
Completed application near slide tops

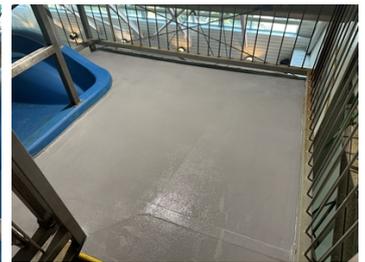
Finished application
