# BELZONA REPAIRS EBONITE COVERED CARPET ROLL

ID: 975

**Customer Location:** Carpet manufacturer, Kidderminster, UK  
**Application Date:** June 2008

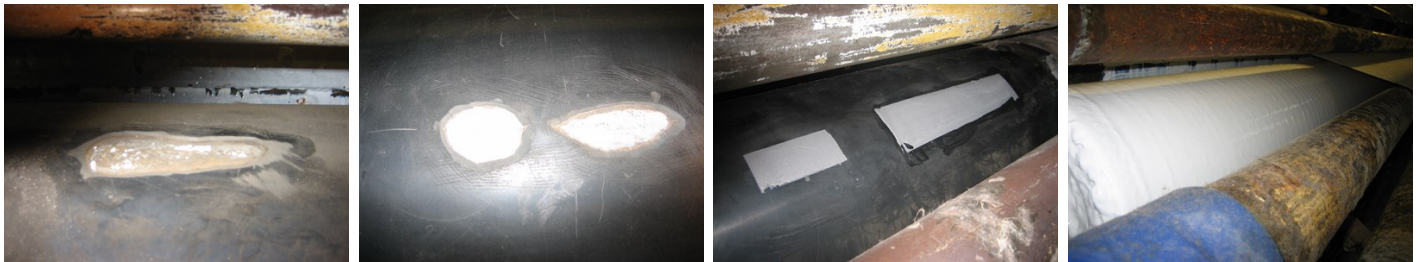
*The ebonite had suffered from localised wear and was not readily repairable. In fact the original manufacturer did not recomend repair of this material*

- \* Roll showing area of missing Ebonite ,
- \* Two damaged areas, the left side prepared the right yet to be prepared ,
- \* The two areas brought back to profile with Belzona® 1111 ,
- \* The Latex Applicator back in action ,

Application was carried out in accordance with a modified version of Belzona Know-How System TCC-3. Ebonite was cut back to a sound edge and after roughening exposed steel and surrounding Ebonite, Belzona® 1111 was applied and then finished to profile using sa template cut from a Belzona Mixing Board.
