# Belzona Repairs Split Case Pump

ID: 9753

Industry: Water / Wastewater  
Application: CEP-Centrifugal Pumps  
Substrate: Cast Iron  
Products: Belzona 1341 (Supermetalgilde)

Customer Location: Melbourne Australia  
Application Date: January 2025

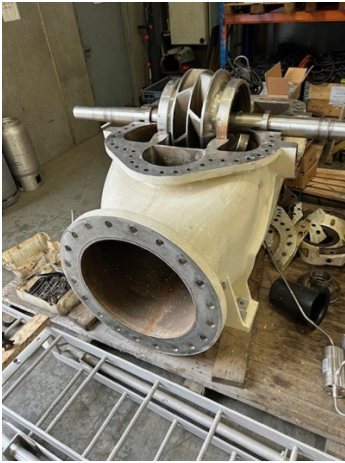
Split case pump prior to application.

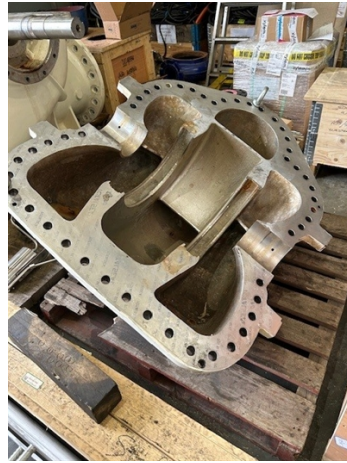
Internal split case pump prior to application

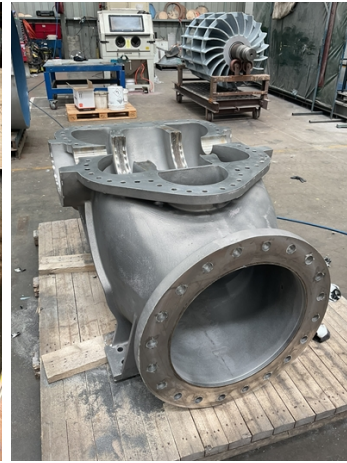
Pump casing abrasive blasted, ready for Belzona coating.

Pump was received into our workshop. Surface prep and clean carried out and an internal coating using Belzona 1341 (Supermetalgilde). External of the pump was coated in a 2 pac paint as per customers specification.
