Belzona Repairs Split Case Pump

ID: 9753

Industry: Water / Wastewater
Application: CEP-Centrifugal Pumps
Substrate: Cast Iron
Products: Belzona 1341 (Supermetalgilde)

Customer Location: Melbourne Australia
Application Date: January 2025

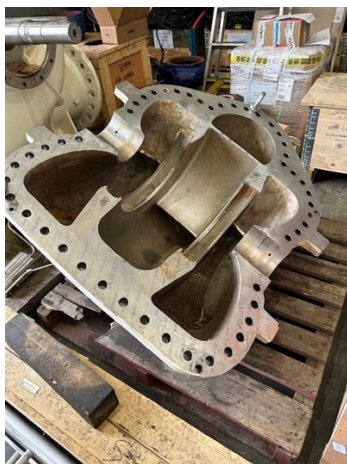
Internal split case pump prior to application

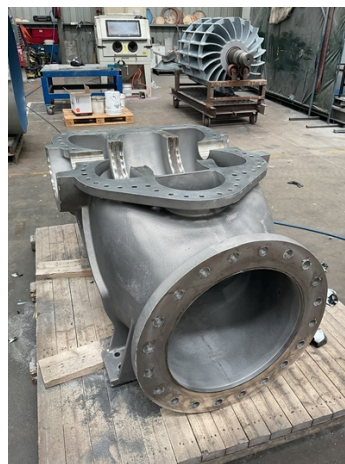
Pump casing abrasive blasted, ready for Belzona coating.

Pump was received into our workshop. Surface prep and clean carried out and an internal coating using Belzona 1341 (Supermetalgilde). External of the pump was coated in a 2 pac paint as per customers specification.

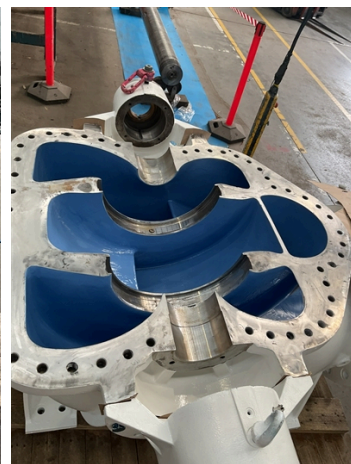
Belzona 1341 (Supermetalgilde) coating carried out.
