# BELZONA SOLUTION FOR REFURBISHMENT OF PUMP CASINGS

ID: 9755

Application: CEP-Centrifugal Pumps

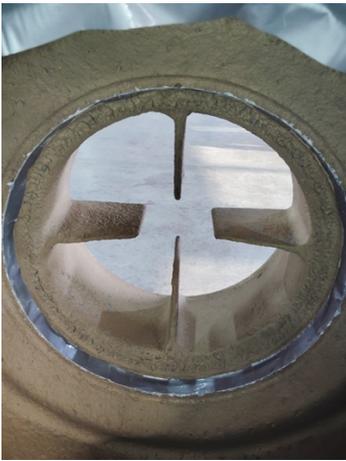
A power station customer is experiencing severe corrosion and material loss in their potable water centrifugal pumps, which are critical for water displacement circulation. This deterioration is driving up maintenance costs, reducing efficiency, and causing unexpected downtime. To restore performance and ensure long-term reliability, the customer requires a durable solution to mitigate corrosion and extend the equipment's service life.

Severe corrosion and material loss in centrifugal pumps.

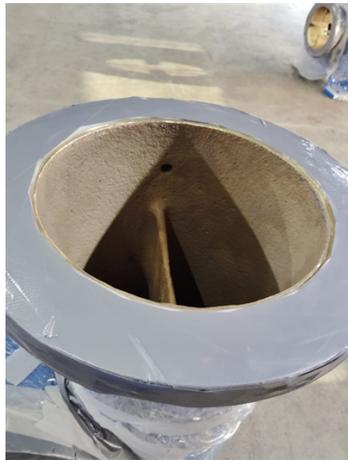
Surface was grit blasted to achieve the required profile.

1. After thorough cleaning, the surface was grit blasted to achieve the required profile.
2. Damaged areas were repaired with Belzona 1121 (Super XL-Metal) for a strong, long-lasting restoration.
3. Finally, the surface was coated with 2 coats of Belzona 1341 (Supermetalgilde), strictly adhering to the manufacturer's Instructions for Use (IFU) to ensure maximum protection and performance.

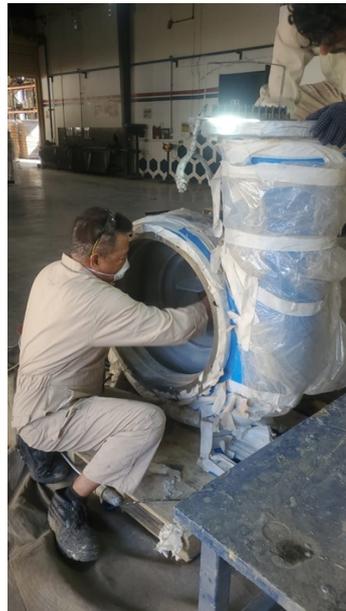
Application of Belzona 1121 for a strong, long-lasting restoration.
