# BELZONA SOLUTION FOR REFURBISHMENT OF PUMP CASINGS

Application: CEP-Centrifugal Pumps

Customer Location: ABU DHABI, UNITED ARAB EMIRATES

Application Date: February 2025

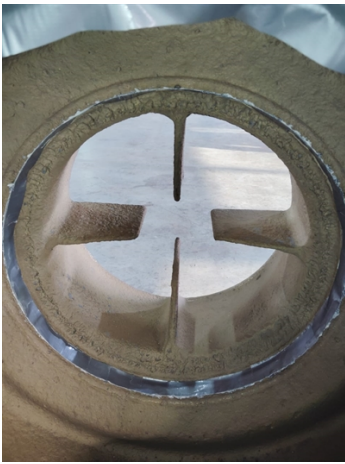
A power station customer is experiencing severe corrosion and material loss in their potable water centrifugal pumps, which are critical for water displacement circulation. This deterioration is driving up maintenance costs, reducing efficiency, and causing unexpected downtime. To restore performance and ensure long-term reliability, the customer requires a durable solution to mitigate corrosion and extend the equipment's service life.

Severe corrosion and material loss in centrifugal pumps.

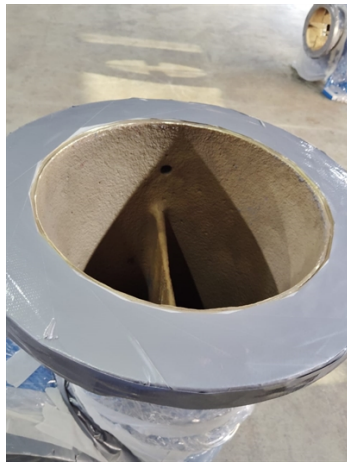
Surface was grit blasted to achieve the required profile.

1. After thorough cleaning, the surface was grit blasted to achieve the required profile.
2. Damaged areas were repaired with Belzona 1121 (Super XL-Metal) for a strong, long-lasting restoration.
3. Finally, the surface was coated with 2 coats of Belzona 1341 (Supermetalgilde), strictly adhering to the manufacturer's Instructions for Use (IFU) to ensure maximum protection and performance.

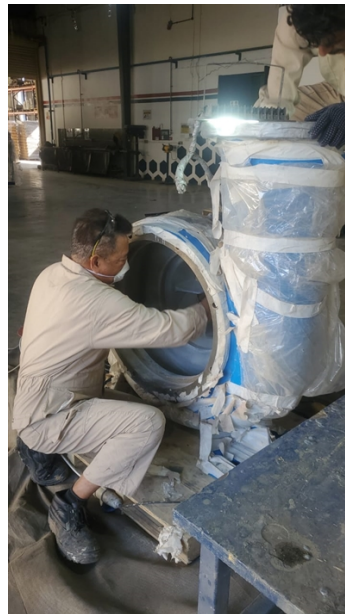
Application of Belzona 1121 for a strong, long-lasting restoration.
