Belzona Chocking System Installed at a Papermill

ID: 9758

Industry: *Pulp & Paper*
Application: *GSS-Gaskets, Seals and Shims*
Substrate: *Concrete*
Products: *Belzona 7111, Belzona 9411 (Release Agent)*

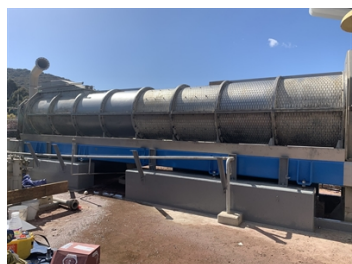
Screw press requires a high-performance chocking at the support legs to ensure stability and minimize vibrations

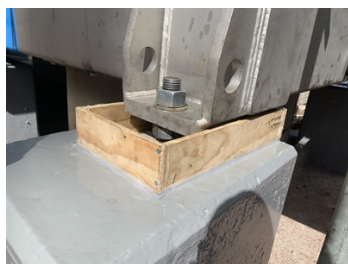
Formwork was built around the support legs before pouring the Belzona chocking system

1. Timber battens were coated in Belzona 9411 Release Agent
2. A dam was created in 16 locations using screws and silicon, left to cure overnight.
3. Belzona 7111 was mixed and poured in accordance with Belzona 7111 IFU, and was left to cure for 24 hours before removing timber battens.

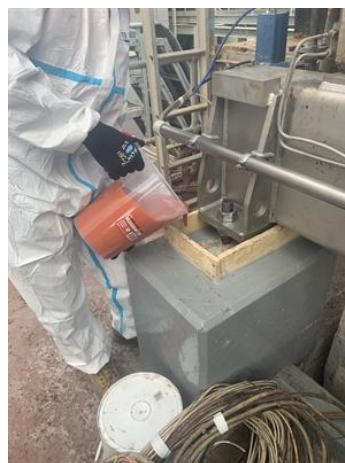
Pouring Belzona 7111

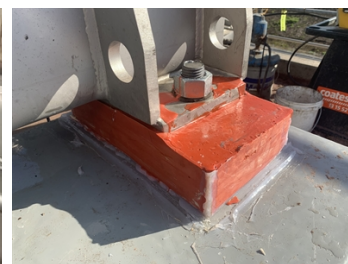
Completed application of Belzona 7111, 100% solids chocking/grouting material

Belzona 7111 was used as it is a self leveling system to create a perfectly even base for the screw press.
