Belzona Chocking System Installed at a Papermill

ID: 9758

Industry: *Pulp & Paper*
Application: *GSS-Gaskets, Seals and Shims*
Substrate: *Concrete*
Products: *Belzona 7111, Belzona 9411 (Release Agent)*

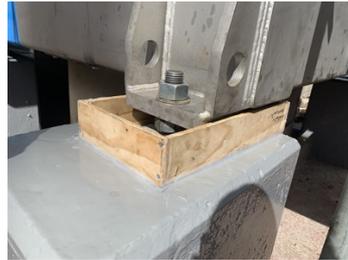
Screw press requires a high-performance chocking at the support legs to ensure stability and minimize vibrations

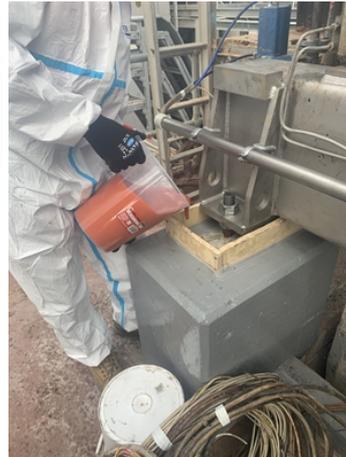
Formwork was built around the support legs before pouring the Belzona chocking system

1. Timber battens were coated in Belzona 9411 Release Agent
2. A dam was created in 16 locations using screws and silicon, left to cure overnight.
3. Belzona 7111 was mixed and poured in accordance with Belzona 7111 IFU, and was left to cure for 24 hours before removing timber battens.

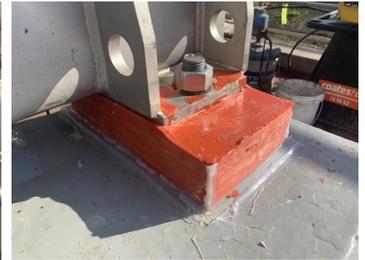
Pouring Belzona 7111

Completed application of Belzona 7111, 100% solids chocking/grouting material
