# BELZONA SOLUTION FOR REBUILDING & COATING OF STRUCTURE OF VESSEL'S HATCHES

ID: 9759

Industry: Marine  
Application: SOS-Ships and Offshore Structures

Substrate: Aluminum  
Products: Belzona 1161 (Super UW-Metal), Belzona 1321 (Ceramic S-Metal), Belzona 9111 (Cleaner Degreaser)

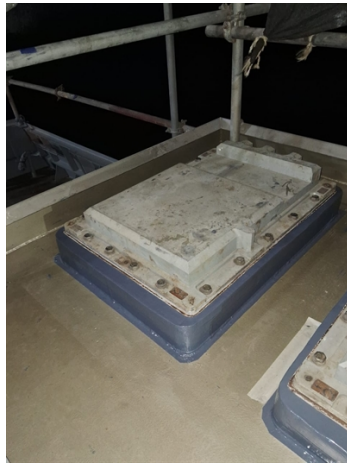
The vessel's hatch structures suffered severe corrosion due to prolonged exposure to seawater and the harsh marine environment.
