BELZONA SOLUTION FOR REBUILDING AND COATING OF GLOBE VALVE

ID: 9760

Industry: Oil & Gas
Application: VPF-Valves, Pipes and Fittings
Substrate: Bronze
Products: Belzona 1111 (Super Metal), Belzona 1321 (Ceramic S-Metal)

Customer Location: ABU DHABI, UNITED ARAB EMIRATES
Application Date: February 2024

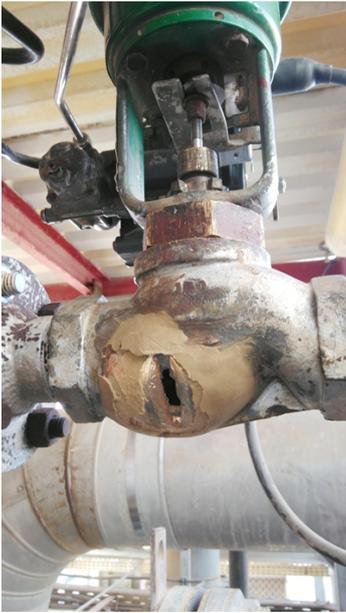
An offshore customer faced an issue with a globe valve that had developed a hole, leading to operational disruptions. To minimize downtime, they required an immediate solution to restore normal operations.

Globe valve that had developed a hole, leading to operational disruptions.
