BELZONA SOLUTION FOR REBUILDING AND COATING OF GLOBE VALVE

ID: 9760

Industry: Oil & Gas
Application: VPF-Valves, Pipes and Fittings
Substrate: Bronze
Products: Belzona 1111 (Super Metal), Belzona 1321 (Ceramic S-Metal)

Customer Location: ABU DHABI, UNITED ARAB EMIRATES
Application Date: February 2024

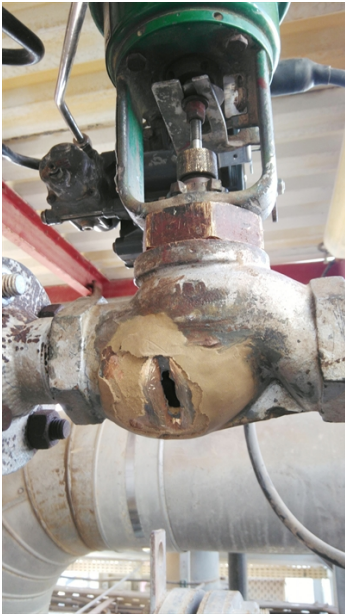
Globe valve that had developed a hole, leading to operational disruptions.
