BELZONA SOLUTION FOR REBUILDING AND COATING OF CHILLERS

ID: 9762

Industry: Heating, Ventilation & Air Conditioning
Application: HEX-Heat Exchangers
Substrate: Carbon steel
Products: Belzona 1121 (Super XL-Metal), Belzona 5821

Customer Location: DUBAI, UNITED ARAB EMIRATES
Application Date: January 2025

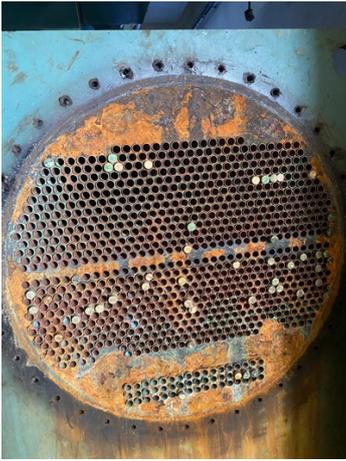
The tube sheet and end cover of the chiller units experienced severe corrosion, resulting in a significant decline in efficiency. Additionally, the wear around the gasket seals prevented a proper seal, further impacting the chiller's performance.

Tube sheet and end cover of the chiller units experienced severe corrosion.

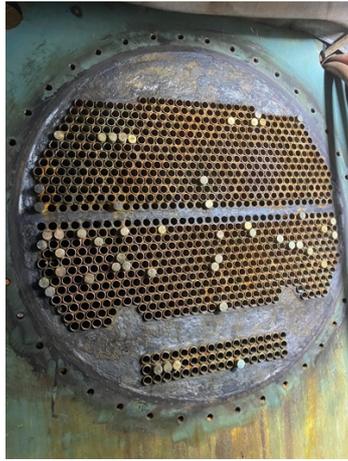
Surface was grit blasted and thoroughly cleaned.

1. The surface was grit blasted and thoroughly cleaned.
2. Plastic/rubber plugs were inserted during surface preparation to prevent media from entering the tubes. These plugs were then removed and reapplied before the product application.
3. Belzona 1121 (Super XL-Metal) was used to rebuild and resurface the worn areas, while Belzona 5821 was applied as a two-coat system to protect the tube sheet and end cover from corrosion and erosion.

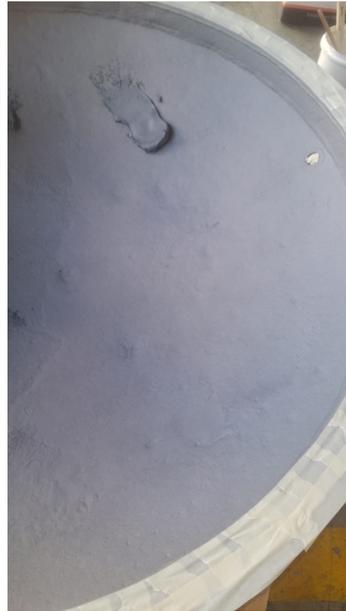
Belzona 1121 (Super XL-Metal) was used to rebuild and resurface the worn areas.

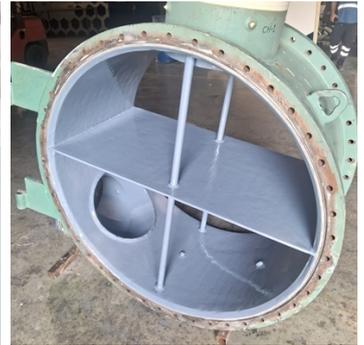
Belzona 5821 was applied as a two-coat system to protect the tube sheet and end cover from corrosion and erosion.
