BELZONA SOLUTION FOR REBUILDING AND COATING OF CHILLERS

ID: 9762

Industry: Heating, Ventilation & Air Conditioning
Application: HEX-Heat Exchangers
Substrate: Carbon steel
Products: Belzona 1121 (Super XL-Metal), Belzona 5821

Customer Location: DUBAI, UNITED ARAB EMIRATES
Application Date: January 2025

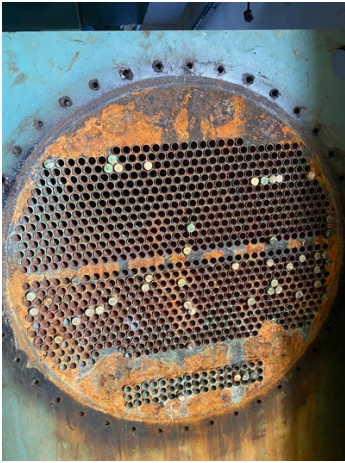
The tube sheet and end cover of the chiller units experienced severe corrosion, resulting in a significant decline in efficiency. Additionally, the wear around the gasket seals prevented a proper seal, further impacting the chiller's performance.

Tube sheet and end cover of the chiller units experienced severe corrosion.

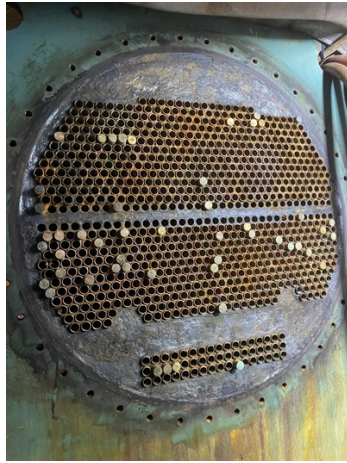
Surface was grit blasted and thoroughly cleaned.

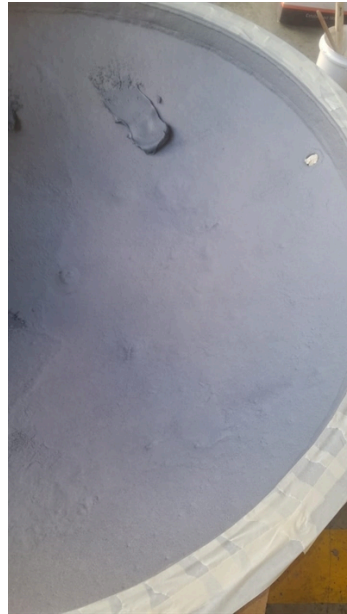
Belzona 1121 (Super XL-Metal) was used to rebuild and resurface the worn areas.

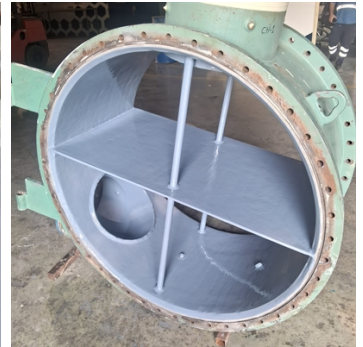
Belzona 5821 was applied as a two-coat system to protect the tube sheet and end cover from corrosion and erosion.
