BELZONA SOLUTION FOR REBUILDING AND COATING OF CHILLERS

ID: 9762

Industry: Heating, Ventilation & Air Conditioning
Application: HEX-Heat Exchangers
Substrate: Carbon steel
Products: Belzona 1121 (Super XL-Metal), Belzona 5821

Customer Location: DUBAI, UNITED ARAB EMIRATES
Application Date: January 2025

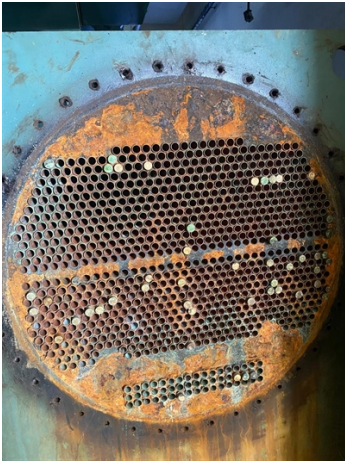
The tube sheet and end cover of the chiller units experienced severe corrosion, resulting in a significant decline in efficiency. Additionally, the wear around the gasket seals prevented a proper seal, further impacting the chiller's performance.

Tube sheet and end cover of the chiller units experienced severe corrosion.

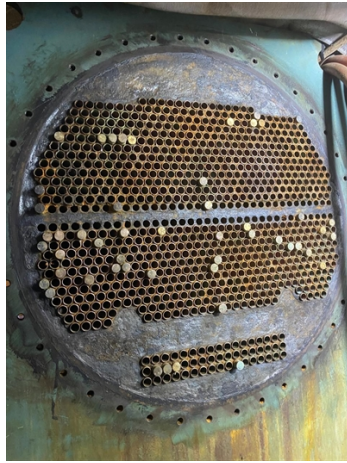
Surface was grit blasted and thoroughly cleaned.

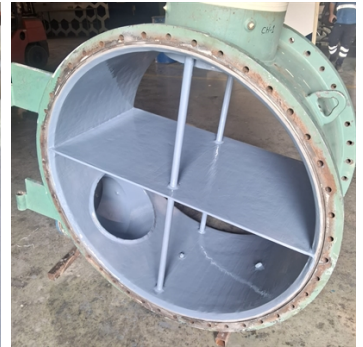
Belzona 5821 was applied as a two-coat system to protect the tube sheet and end cover from corrosion and erosion.
