Belzona helps to rebuilding and coating the Chiller with 1111 and 1321

ID: 9763

Application: HEX-Heat Exchangers

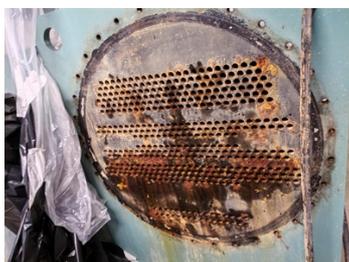
The customer was experiencing corrosion and erosion on the tube sheet, waterbox, and covers. The previously applied coating was unsuitable for the operating environment and failed to prevent damage. As a result, the customer sought a durable coating solution capable of withstanding corrosion and erosion while repairing internal tube damage without the need for welding.

Tubesheet face before blasting and coating

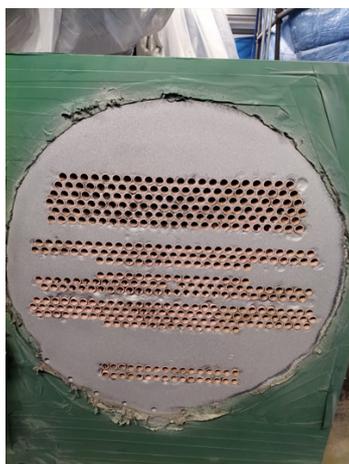
Tubesheet face after blasting

After blasting, significant metal loss was evident on the tubesheet face, requiring rebuilding with Belzona 1111

We began by blasting the surface with coal slag grit to achieve a minimum 75 µm profile and near white metal cleanliness. Next, we rebuilt the surface using Belzona 1111 (Super Metal) to fill in the pitting and repair the metal loss on the tubesheet face and covers. Finally, we applied two coats of Belzona 1321 (Ceramic S-Metal), each with a thickness of 375 µm, to achieve a total dry film thickness (DFT) of 750 µm.

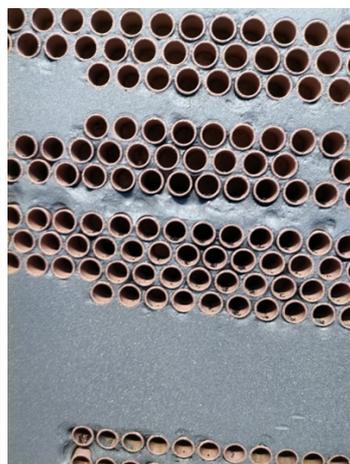
Final stage after Belzona rebuilding and coating
