# Belzona helps to rebuilding and coating the Chiller with 1111 and 1321

Application: HEX-Heat Exchangers

Products: Belzona 1111 (Super Metal), Belzona 1321 (Ceramic S-Metal)

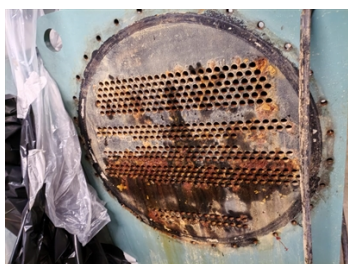
Tubesheet face before blasting and coating

We began by blasting the surface with coal slag grit to achieve a minimum 75 µm profile and near white metal cleanliness. Next, we rebuilt the surface using Belzona 1111 (Super Metal) to fill in the pitting and repair the metal loss on the tubesheet face and covers. Finally, we applied two coats of Belzona 1321 (Ceramic S-Metal), each with a thickness of 375 µm, to achieve a total dry film thickness (DFT) of 750 µm.

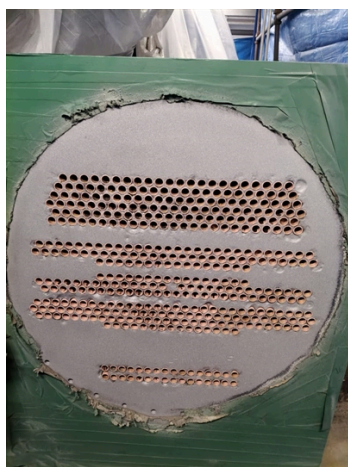
Tubesheet face after blasting

After blasting, significant metal loss was evident on the tubesheet face, requiring rebuilding with Belzona 1111
