Belzona Protects Guide Veins at a Hydro Power Station

ID: 9764

Industry: Power
Application: VPF-Valves, Pipes and Fittings
Substrate: Cast Iron
Products: Belzona 1341 (Supermetalglide)

Customer Location: NSW Australia
Application Date: July 2024

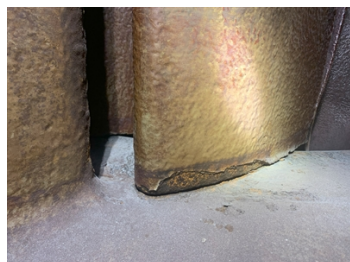
The existing coating on the guide veins at the end of the penstock at the entry point to the impeller of the turbine, was starting to show the effects of erosion and corrosion.

Existing condition of guide veins

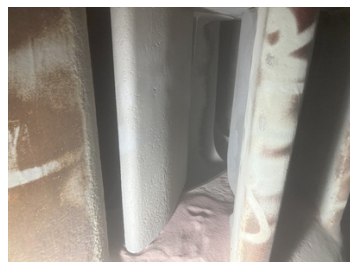
Guide Veins after blasting

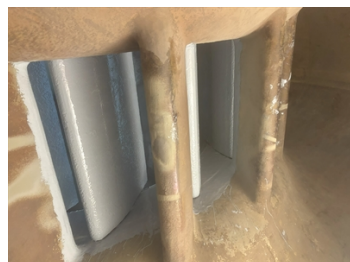
First Coat of 1341 Grey

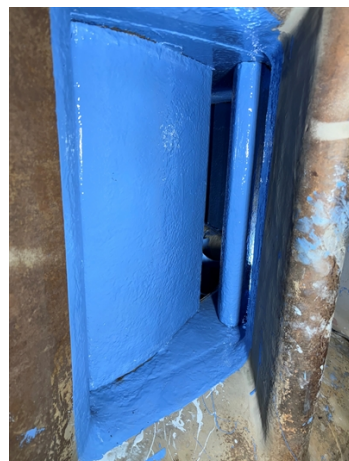
Completed with second coat of Belzona 1341 Blue
