# Belzona Protects Guide Veins at a Hydro Power Station

ID: 9764

Industry: Power  
Application: VPF-Valves, Pipes and Fittings  
Substrate: Cast Iron  
Products: Belzona 1341 (Supermetalglide)

Customer Location: NSW Australia  
Application Date: July 2024

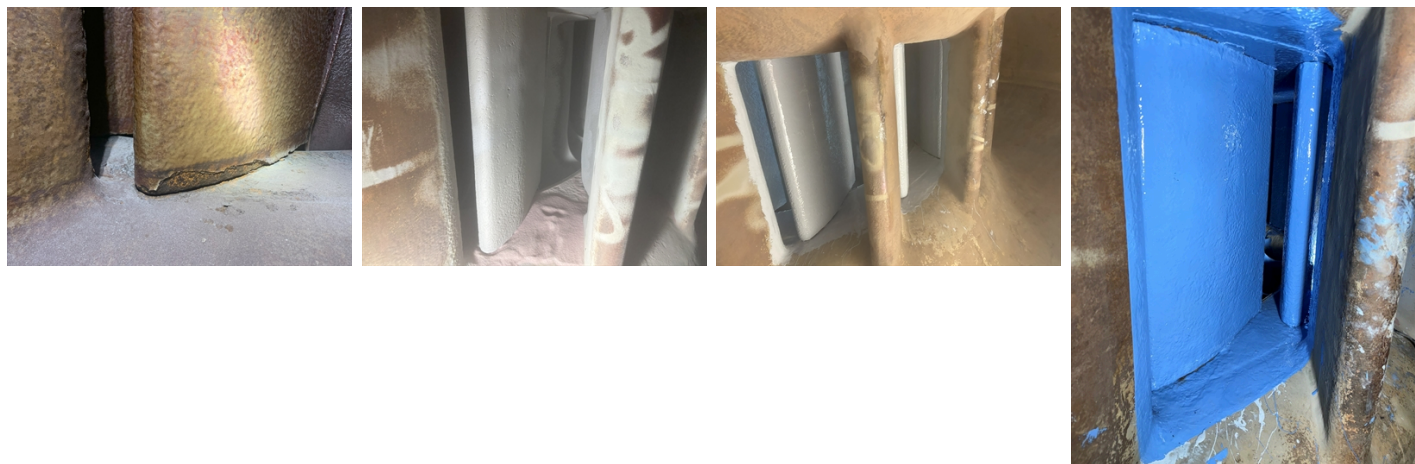
The existing coating on the guide veins at the end of the penstock at the entry point to the impeller of the turbine, was starting to show the effects of erosion and corrosion.

Existing condition of guide veins

Guide Veins after blasting

First Coat of 1341 Grey

Completed with second coat of Belzona 1341 Blue

Belzona 1341 Super Metal Glide was recommended as this 2-coat system is designed to improve the efficiency of fluid handling equipment.

The application was completed by the Rezitech Services onsite team in under a week ensuring a quick turnaround and minimal downtime for the Hydro Station.
