Belzona Protects Guide Veins at a Hydro Power Station

ID: 9764

Industry: Power
Application: VPF-Valves, Pipes and Fittings
Substrate: Cast Iron
Products: Belzona 1341 (Supermetalglide)

Customer Location: NSW Australia
Application Date: July 2024

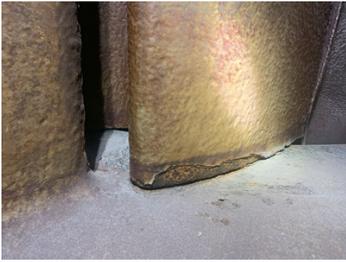
The existing coating on the guide veins at the end of the penstock at the entry point to the impeller of the turbine, was starting to show the effects of erosion and corrosion.

Existing condition of guide veins

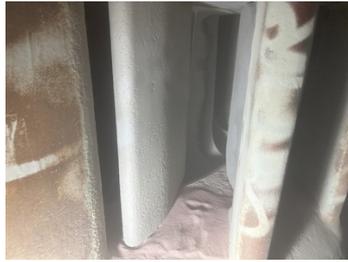
Guide Veins after blasting

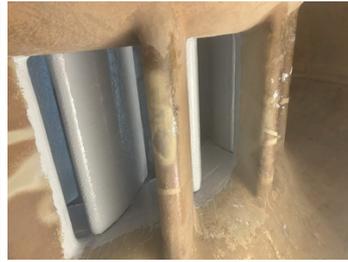
First Coat of 1341 Grey

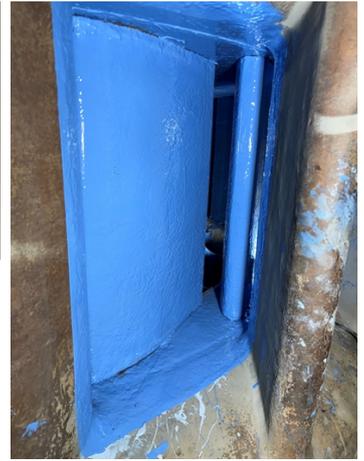
Completed with second coat of Belzona 1341 Blue

Belzona 1341 Super Metal Glide was recommended as this 2-coat system is designed to improve the efficiency of fluid handling equipment.

The application was completed by the Rezitech Services onsite team in under a week ensuring a quick turnaround and minimal downtime for the Hydro Station.
