# Belzona helps to protect HVAC End Covers Suffering Erosion & Corrosion

ID: 9765

Industry: Chemical & Petrochemical  
Application: HEX-Heat Exchangers  
Substrate: Cast Iron  
Products: Belzona 1391T

Customer Location: NSW Australia  
Application Date: May 2023

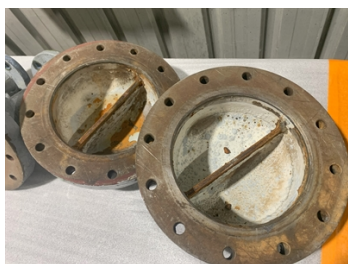
The asset owner was search for solutions for HVAC end covers that suffered from erosion and corrosion.

Existing condition of HVAC end covers suffered erosion & corrosion

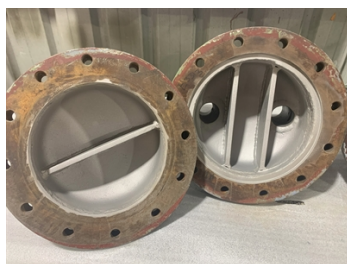
End covers were blasted for further repair steps

The end covers were abrasive blasted and coated with Belzona 1391T by the Belzona distributor for Australia, Rezitech Services team in Sydney.

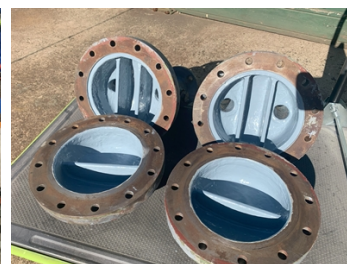
End covers completed with second coat Belzona 1391T Blue

Inspections have been extended to 8 year intervals saving downtime on critical process equipment
