Belzona helps to protect HVAC End Covers Suffering Erosion & Corrosion

ID: 9765

Industry: *Chemical & Petrochemical*
Application: *HEX-Heat Exchangers*
Substrate: *Cast Iron*
Products: *Belzona 1391T*

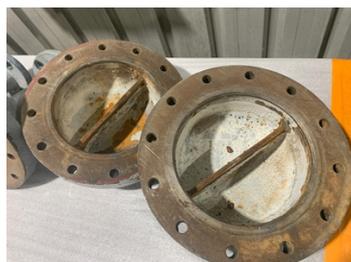
Existing condition of HVAC end covers suffered erosion & corrosion

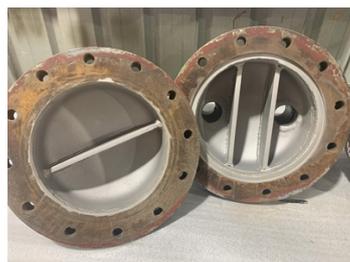
End covers were blasted for further repair steps

The end covers were abrasive blasted and coated with Belzona 1391T by the Belzona distributor for Australia, Rezitech Services team in Sydney.

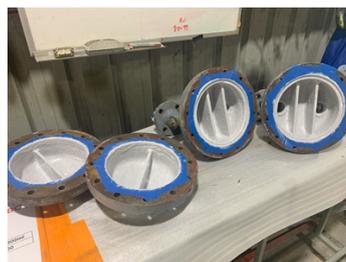
First coat of Belzona 1391T Grey

Belzona 1391T was recommend due to the elevated temperature of 85°C.

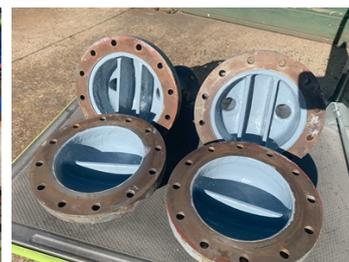
End covers completed with second coat Belzona 1391T Blue
