BELZONA SOLUTION FOR INTERNAL REBUILDING & COATING OF PUMP DIFFUSER BOWL

Application: CEP-Centrifugal Pumps

Customer Location: ABU DHABI, UNITED ARAB EMIRATES

Application Date: January 2015

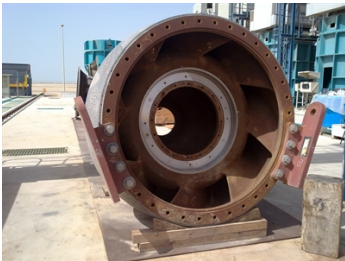
Extensive corrosion in a power station's seawater intake pump diffuser bowl and vanes from prolonged marine exposure is undermining efficiency, reliability, and structural integrity.
