BELZONA SOLUTION FOR INTERNAL REBUILDING & COATING OF PUMP DIFFUSER BOWL

ID: 9766

Application: CEP-Centrifugal Pumps

Customer Location: ABU DHABI, UNITED ARAB EMIRATES

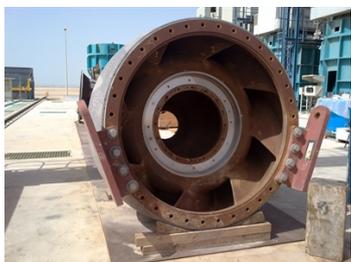
Extensive corrosion in a power station's seawater intake pump diffuser bowl and vanes from prolonged marine exposure is undermining efficiency, reliability, and structural integrity.
