Belzona Superwrap II Restores Fuel Storage Tank Pipeline

ID: 9767

Industry: Oil & Gas
Application: VPF-Valves, Pipes and Fittings
Substrate: Carbon steel
Products: Belzona 1211 (E-Metal), Belzona 1982 (SuperWrap II)

Customer Location: NSW Australia
Application Date: September 2023

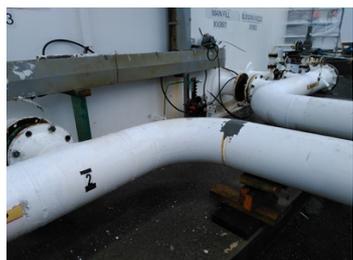
Pipeline to storage tank was suffering from thin wall corrosion at the weld seam.

Pipeline to storage tank.

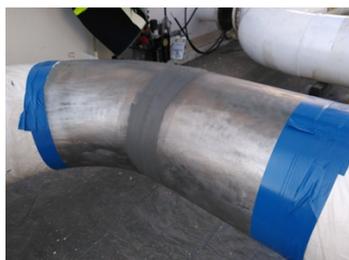
Surface preparation and weld seam rebuilt with Belzona 1212 E Metal

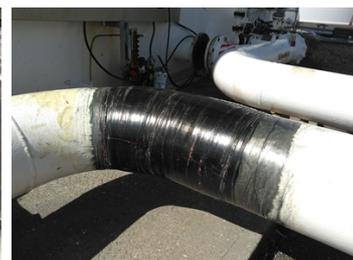
Super Wrap II repair completed

This repair was completed in 2 days ensuring a quick turnaround and return to service.

Belzona Superwrap II 10-year compliant repair installed by the onsite Rezitech Services Team
