Belzona Repairs Winch Housing on a Ship

Industry: *Marine*
Application: *SOS-Ships and Offshore Structures*

Substrate: *Bronze*
Products: *Belzona 1111 (Super Metal), Belzona 5831 (ST-Barrier)*

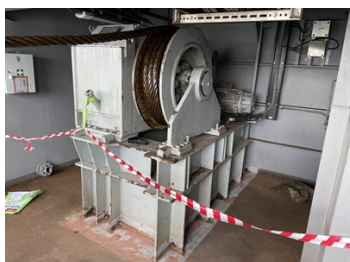
The base of winch housing was suffering from corrosion, raising concerns sea water would contact critical electrical equipment below.

Winch housing in question

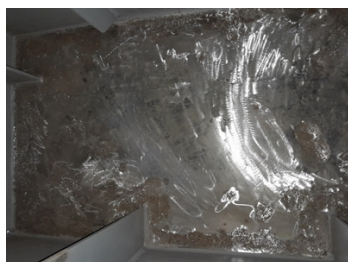
Surface preparation prior to the application of Belzona system

Abrasive blasting was not an option for this repair. Belzona 1111 (Super Metal) and Belzona 5831 (ST-Barrier) were recommended with a minimum required surface preparation of SSPC-SP11.

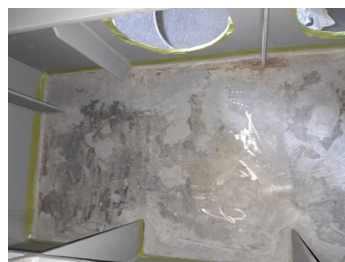
Surface rebuilt with Belzona 1111 (Super Metal)

Base of winch housing needed to be rebuilt and coated as there were concerns that sea water will reach critical electrical equipment below.

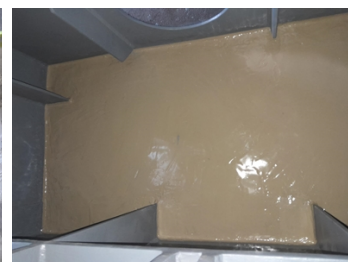
The rebuilt surface was overcoated with Belzona 5831 (ST-Barrier)

This application was completed onsite by ship contractors in three days, enabling a quick return to service.
