# Belzona Repairs Winch Housing on a Ship

ID: 9768

Industry: *Marine*  
Application: *SOS-Ships and Offshore Structures*

Substrate: *Bronze*  
Products: *Belzona 1111 (Super Metal), Belzona 5831 (ST-Barrier)*

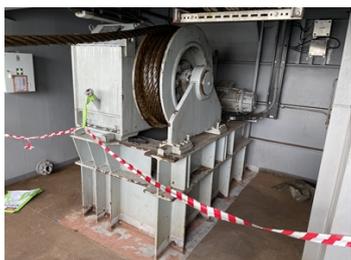
*The base of winch housing was suffering from corrosion, raising concerns sea water would contact critical electrical equipment below.*

Winch housing in question
