# Bearing housing repair with Belzona 1111

Application: *MPT-Mechanical Power Transmission*

Products: *Belzona 1111 (Super Metal)*

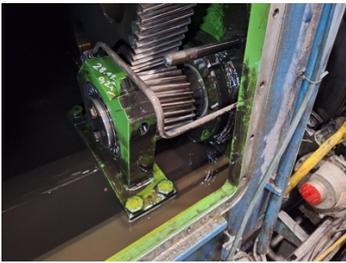
Gearbox with damaged bearing

After prolonged operation, the bearing housing began to vibrate and lost its prescribed geometry. If it were to continue operating, there was a risk of damage to the entire gearbox.

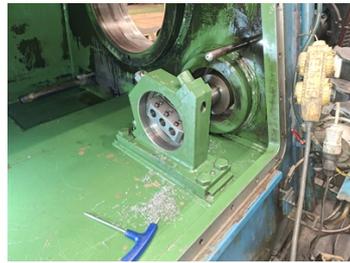
Treatment of damaged surface prior to application of Belzona 1111

The gearbox bearing housing was bored using a mobile boring machine with a VHU boring head. The hole was undercut both in front of and behind the central lubrication groove, which served as a reference plane for centering. The undercut was done using a forged thread cutter. The housing was degreased. Belzona 1111 was then applied. After curing, the Belzona was machined to the final dimension with +0.01.

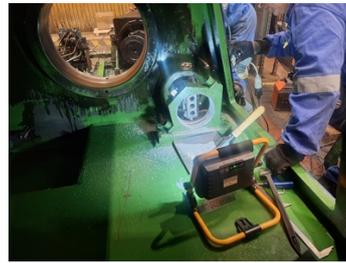
Surface machining after application of Belzona 1111
