# Bearing housing repair with Belzona 1111

Application: *MPT-Mechanical Power Transmission*

Products: *Belzona 1111 (Super Metal)*

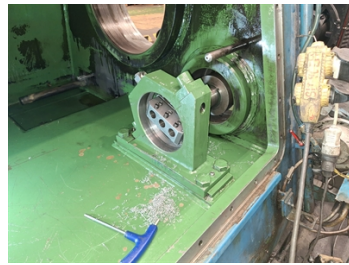
Treatment of damaged surface prior to application of Belzona 1111

The gearbox bearing housing was bored using a mobile boring machine with a VHU boring head. The hole was undercut both in front of and behind the central lubrication groove, which served as a reference plane for centering. The undercut was done using a forged thread cutter. The housing was degreased. Belzona 1111 was then applied. After curing, the Belzona was machined to the final dimension with +0.01.

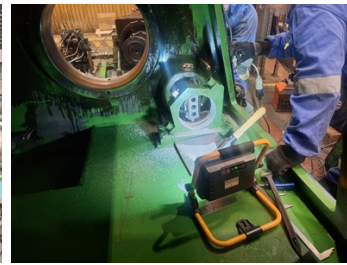
Surface machining after application of Belzona 1111
