BELZONA REPAIRS ORNATE SCHOOL ENTRANCE PORCH

ID: 977

Customer Location: High School, UK

Application Date: April 2008

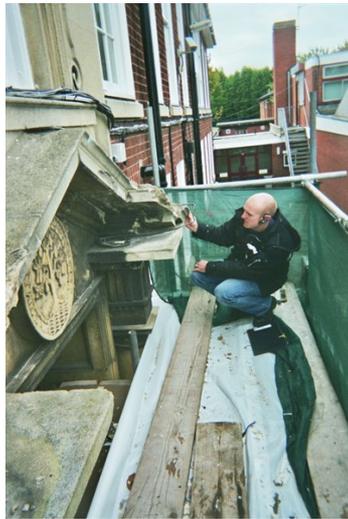
Parts of the cast concrete facade have been lost due to weather conditions, frost and snow in particular.

- * ,
- * Entrance to School with scaffolding and barrier ,
- * Inspection of damaged stonework ,
- * Close Detail of damage ,
- * Completed application after 3 years of weathering ,
- * ,

Application was carried out in accordance with Belzona Know-How System Leaflet WPA-6. Belzona elastomer used to take moulding copies from good areas. Belzona® 4141 then moulded to replicate the weathered areas.

Contractor with assistance from Belzona Consultant devised procedure for restoring this ornate entrance after several other contractors declined the work. The use of Belzona Products and Know-How enabled this impressive entrance to be restored and after 3 years is still looking pristine.
