# METAL PLATE BONDING ON DAM STRUCTURE

ID: 9774

## Problem

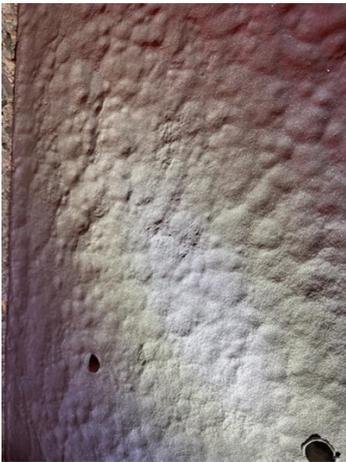
Dam structure was badly worn by erosion of river running beneath and it required reinforcement. Due to the areas affected, welding was not an option. Engineering consulting company specified Belzona to bond metal plated to the structure for reinforcement and corrosion protection.

Structure before metal bonding.

Existing structure and plate was blasted to SSPC SP10 standard of cleanliness. Belzona 1121 was applied on both the structure and the plate for a wet on wet application. Due to freezing conditions, heater were put on to enable proper curing at favourable conditions. Belzona 5811 was then applied to seal the perimeter around the bonding area. Necessary inspections were carried out after few weeks and application was certified okay.

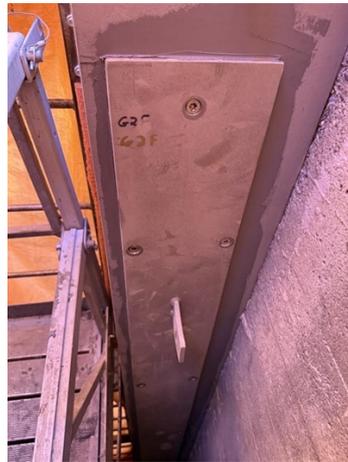
Structure after metal bonding with Belzona 1121.

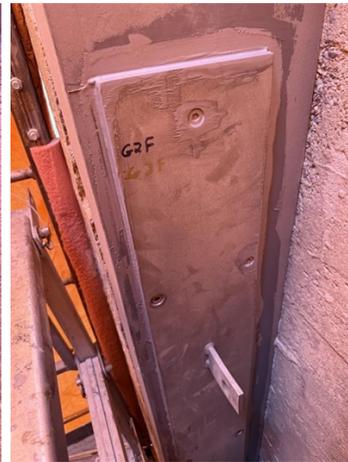
Perimeter of the bonded area coated with Belzona 5811.
