METAL PLATE BONDING ON DAM STRUCTURE

ID: 9774

Industry: Water / Wastewater

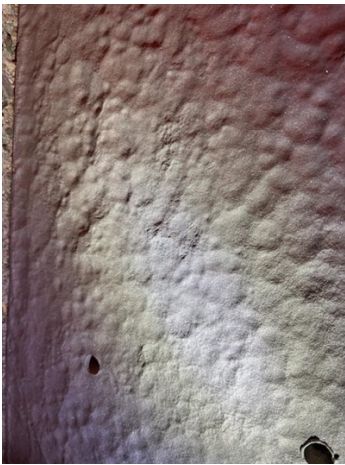
Dam structure was badly worn by erosion of river running beneath and it required reinforcement. Due to the areas affected, welding was not an option. Engineering consulting company specified Belzona to bond metal plated to the structure for reinforcement and corrosion protection.

Structure before metal bonding.

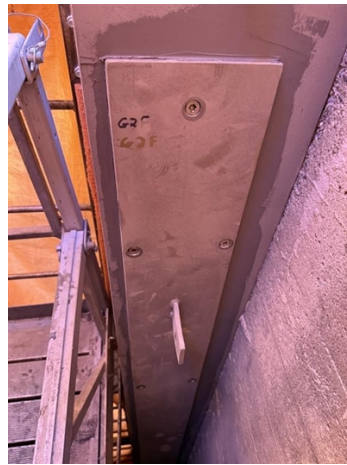
Structure after metal bonding with Belzona 1121.

Existing structure and plate was blasted to SSPC SP10 standard of cleanliness. Belzona 1121 was applied on both the structure and the plate for a wet on wet application. Due to freezing conditions, heater were put on to enable proper curing at favourable conditions. Belzona 5811 was then applied to seal the perimeter around the bonding area. Necessary inspections were carried out after few weeks and application was certified okay.

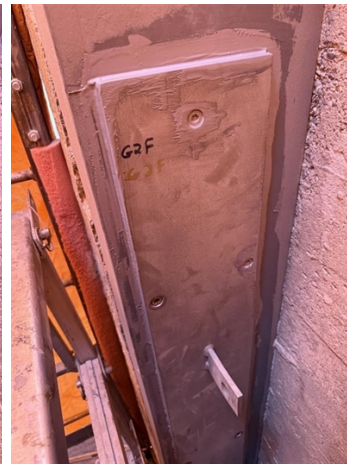
Perimeter of the bonded area coated with Belzona 5811.
