BELZONA HELPS WITH STERN TUBE REALIGNING

ID: 9775

Application: *SOS-Ships and Offshore Structures*

Products: *Belzona 1111 (Super Metal), Belzona 1321 (Ceramic S-Metal)*

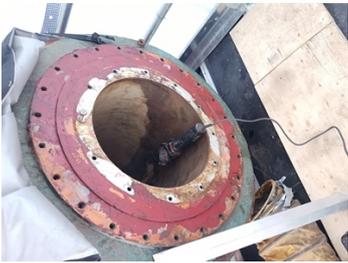
Stern tube after cleaning.

Affected stern tube lining was blasted to the level of cleanliness as instructed in the product IFU. Surface was degreased and Belzona 1111 was applied and machined to the required dimension. Two coats of Belzona 1321 were applied afterwards to seal the area. The application was inspected and passed for the alignment of the propeller.

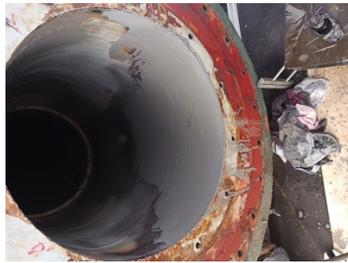
Belzona 1111 application completed.

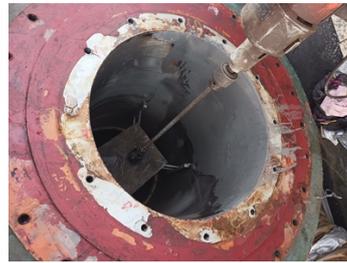
Machining down to required dimensions.

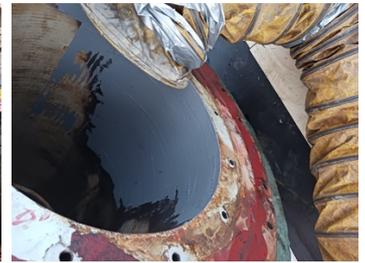
Belzona 1321 application completed.
