Bunker Fuel Transfer Pump Repair

ID: 9776

Industry: *Marine*
Application: *CEP-Centrifugal Pumps*
Substrate: *Carbon steel*
Products: *Belzona 1161 (Super UW-Metal)*

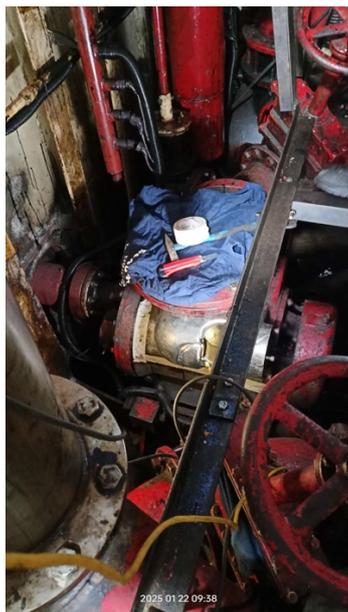
The traditional welding method has failed on a fully propagated crack, resulting in crude oil leakage from the pump bypass valve.

Initial Damage.

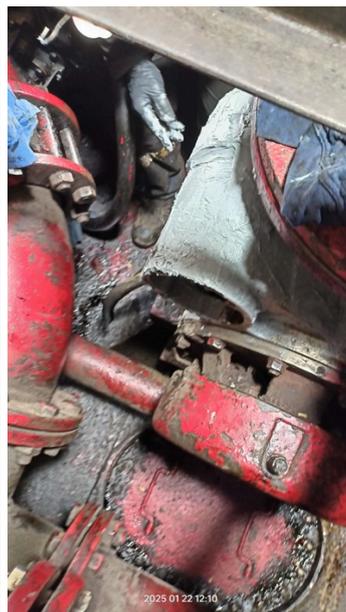
Prepared surface.

The surface was roughened through grinding and subsequently cleaned. A first layer of Belzona 1161 was applied to the internal and external sides of the bypass valve. Belzona Reinforcement tape, embedded on both sides with Belzona 1161, was used to strengthen the repair, which was then covered with an additional layer of Belzona 1161.

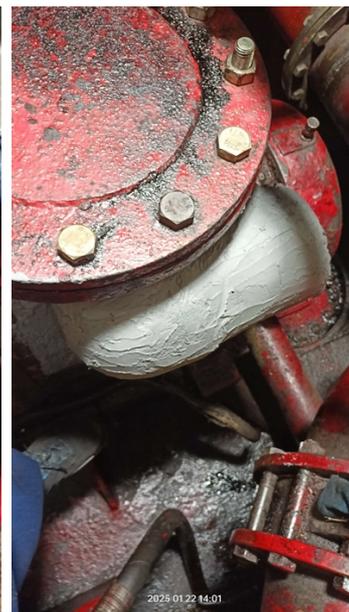
Belzona Super Metal application.
