# Tipping Hall Bays in an Energy From Waste Plant Survive Constant Abrasion with Belzona Solution

Industry: Power  
Application: FPA-Floor Problem Areas  
Substrate: Concrete  
Products: Belzona 5231 (SG Laminate), Belzona 9221 (Surefoot Aggregate White)

Customer Location: Ardley, Oxfordshire  
Application Date: January 2025

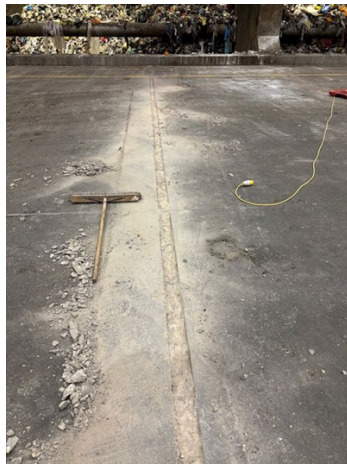
Bay Lanes Being Recessed Into Concrete

Application was carried out using a modified version of Belzona Know-How System Leaflet FPA-4. Channels were cut out 100mm wide by 20 metres long down to a 6mm Depth for the Parking Bay Lines. Numbers 1 - 10 were also recessed between each Bay. A Self-Levelling Screed was made using Belzona 5231 Yellow and 9221 Surefoot aggregate mixed 3:1 and poured into the channels and numbers until they were flush with the concrete.

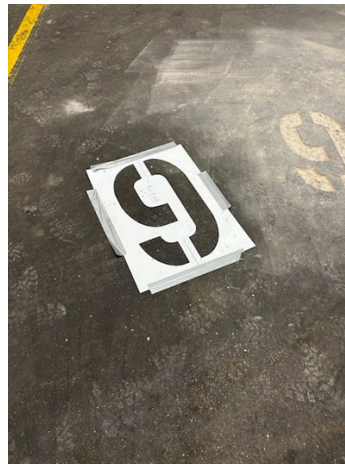
Parking Bay Numbers also Recessed Into Concrete
