# Ship Deck Got The Belzona Plate Bonding Treatment

Industry: Marine

Application: FPA-Floor Problem Areas

Substrate: Carbon steel

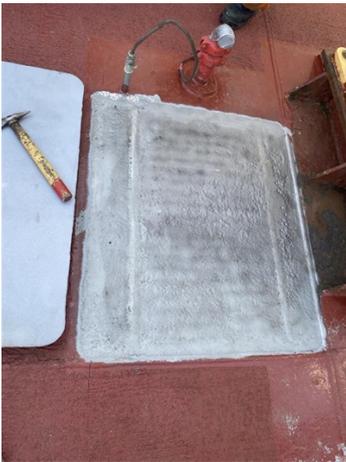
Deck area after abrasive blasting.

Area to be repaired and plate to be bonded were both grit blasted to SSPC SP10 level of cleanliness. Solvent wiping was done afterward to get rid of remaining contaminants after vacuuming. Belzona 1111 was applied separately on both area and the plate and then bonded together to give a wet on wet application. After stabilization, Belzona 5811 was applied on the area to seal the perimeter and also give extra protection.

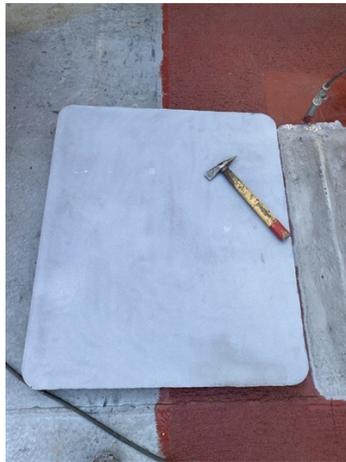
Plate after abrasive blasting.

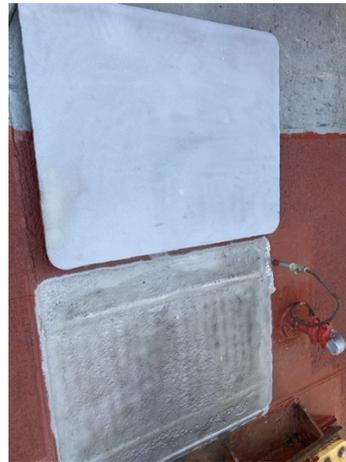
Both side by side.

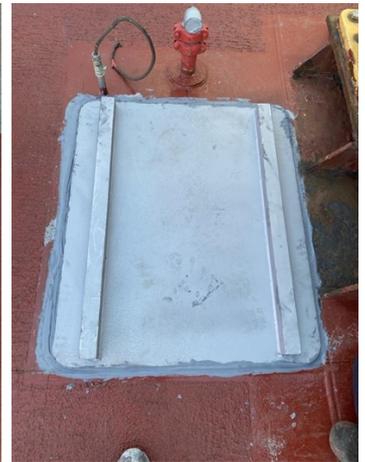
Area after bonding.
