Baler interior was rescued from wear.

ID: 9783

Industry: *Food & Drink*
 Application: *TCC-Tanks and Chemical Containment Areas*
 Substrate: *Carbon steel*
 Products: *Belzona 1121 (Super XL-Metal)*

Customer Location: *Brantford*
 Application Date: *March 2025*

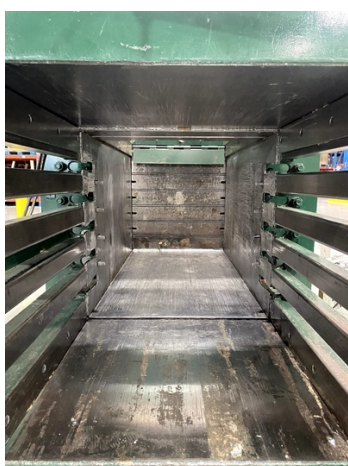
Baler lining after power tool cleaning before application of Belzona 1121.

Power tools were used to clean the surface and create the required profile. Belzona 1121 was mixed and applied, then smoothed to give a more uniform application for ease of ramming of the loader. Equipment was put to test and customer was satisfied with the result.

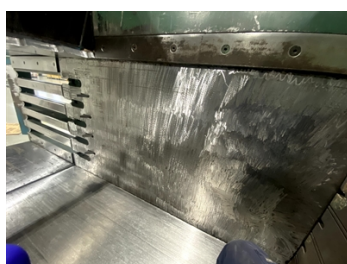
Side view of cleaning.

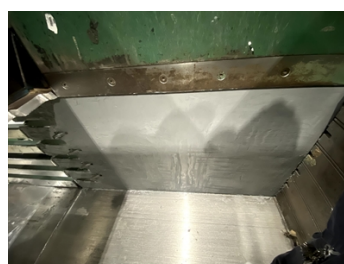
Side view of application.

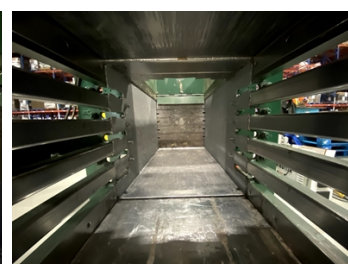
Both sides after application.
